PUBLISHED PROJECT REPORT PPR904

Tyre Ageing

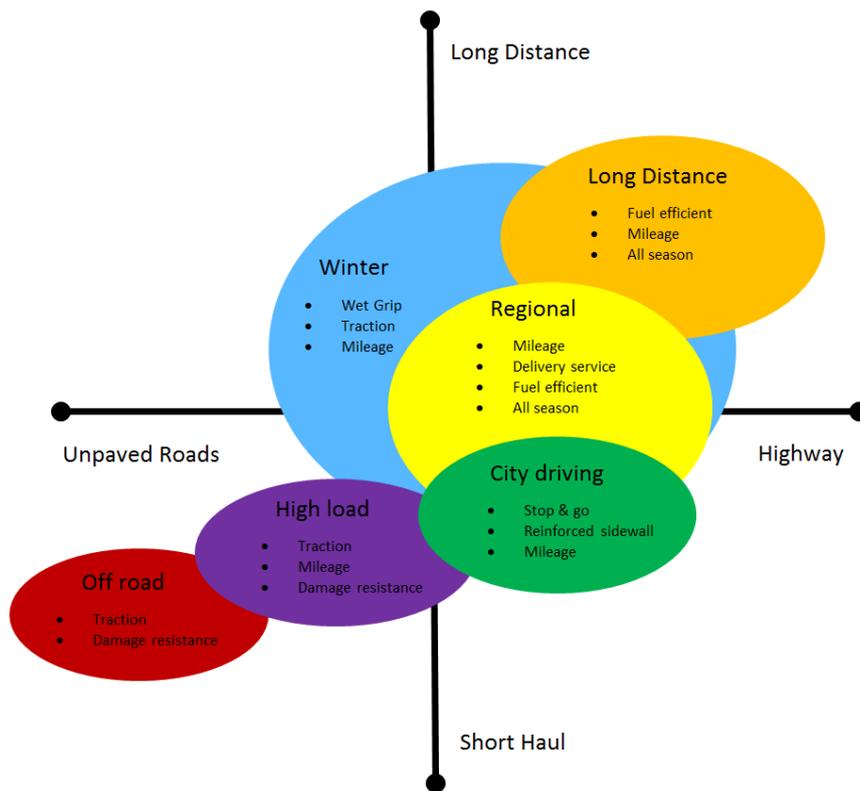
Figure 1: Tyre service applications⁷

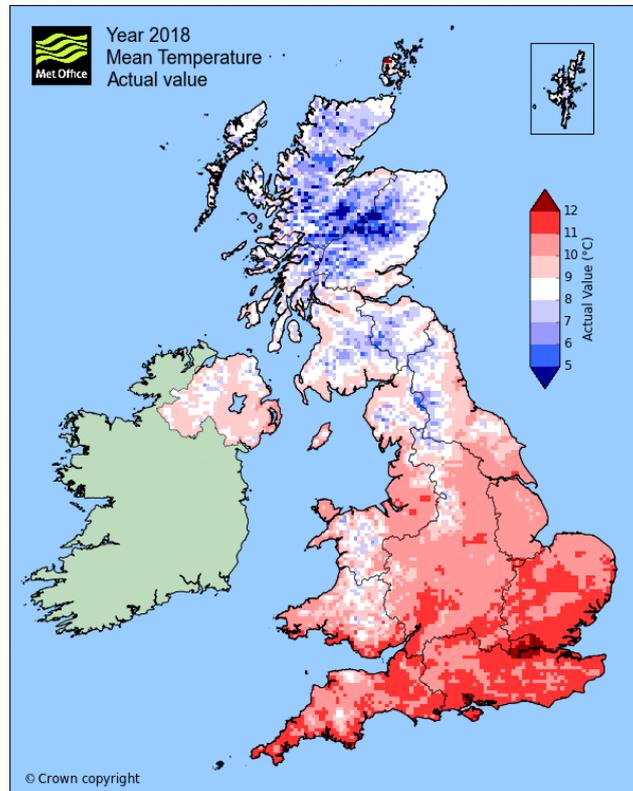
Figure 2: Mean daily temperature UK 0900-0900 GMT

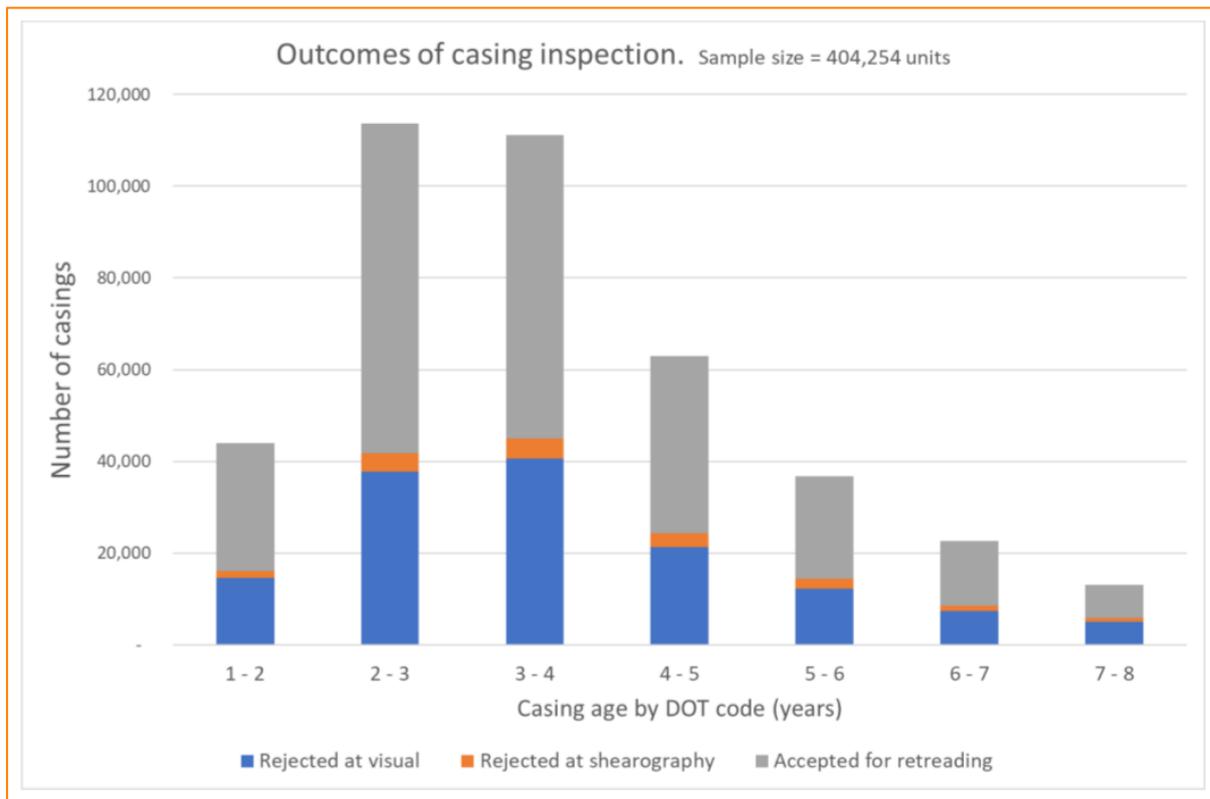
Figure 6: Casing rejection and acceptances by DOT code (years)

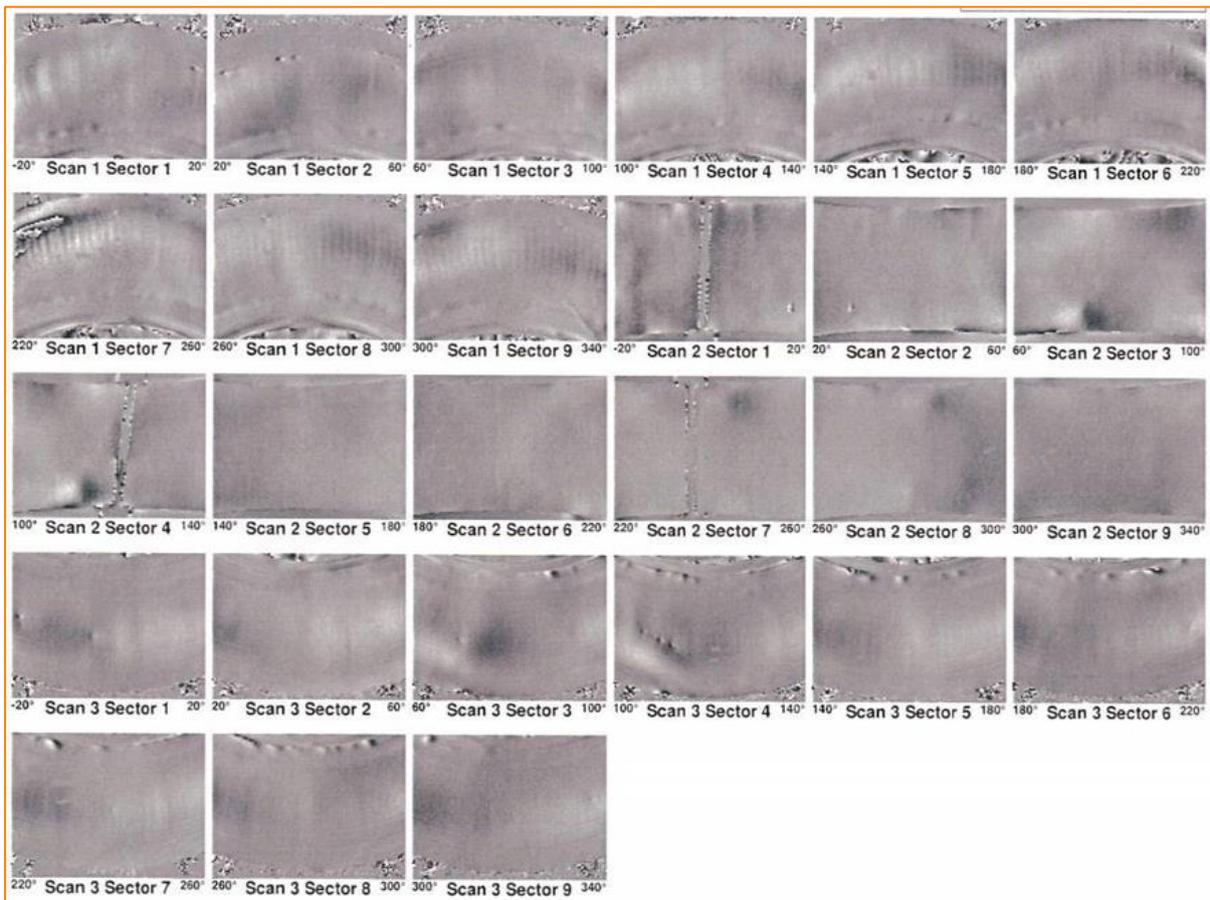
Figure 7: Shearography example, Tyre 20

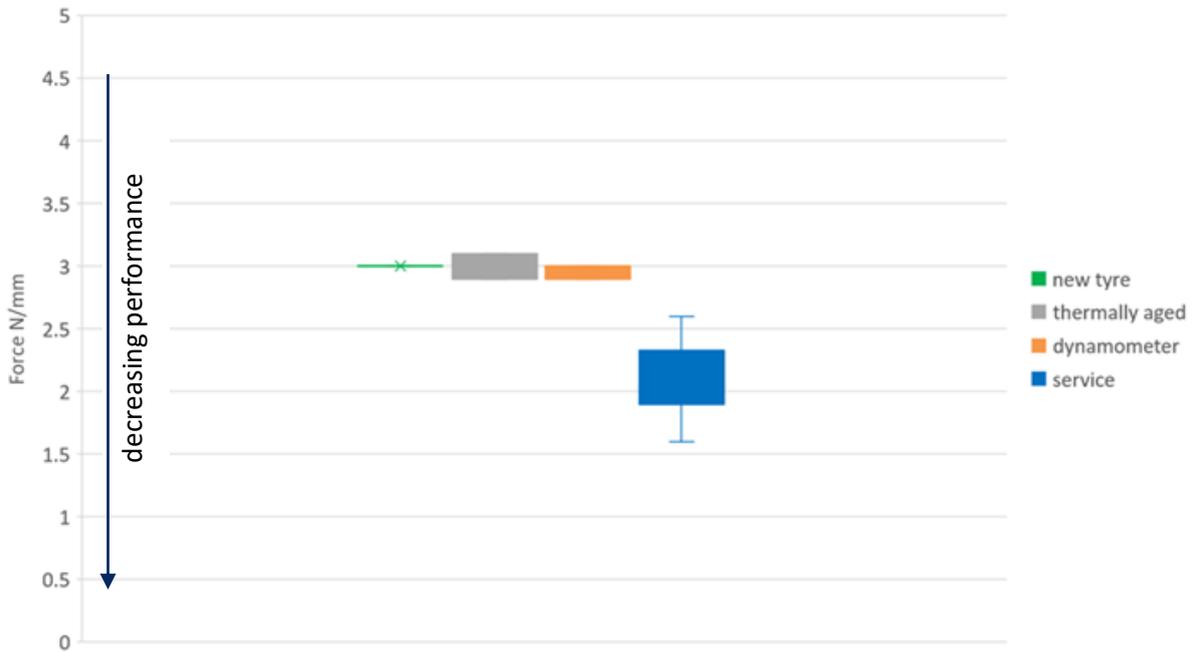
Figure 8: Interfacial peel force, belt 2 to belt 3 (elevated temperature)

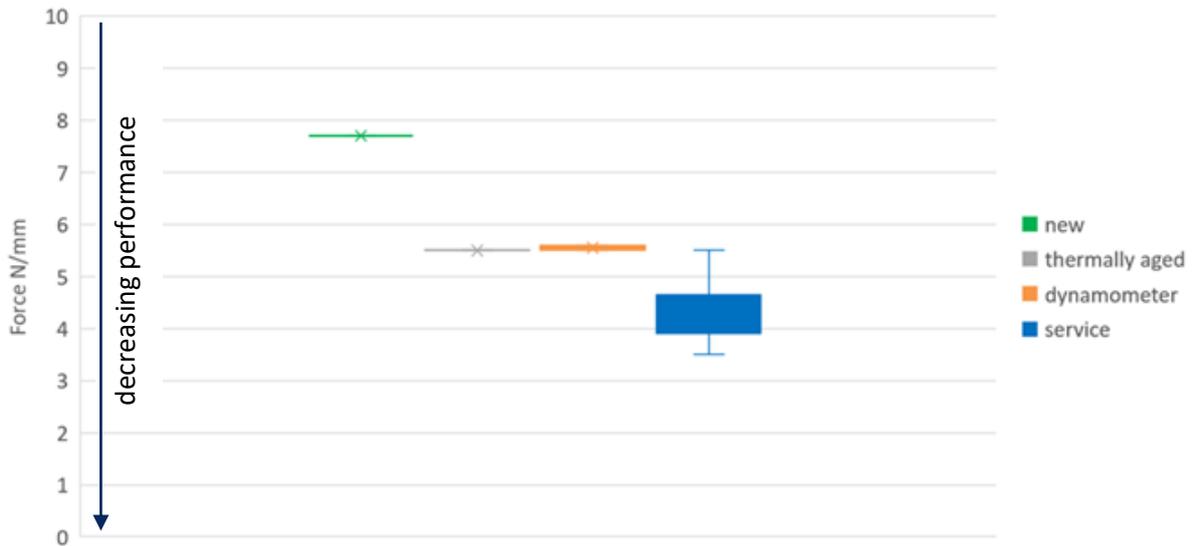
Figure 9: Interfacial peel force, belt 2 to belt 3 (room temperature)

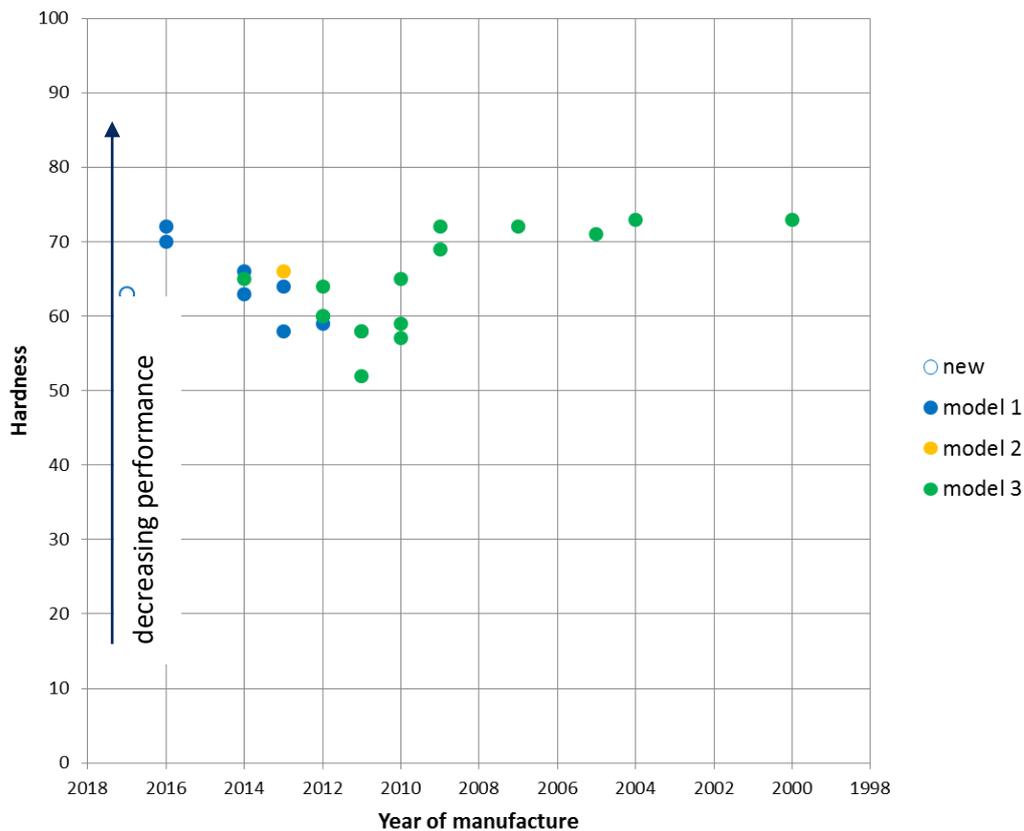
Figure 12: Tread compound hardness

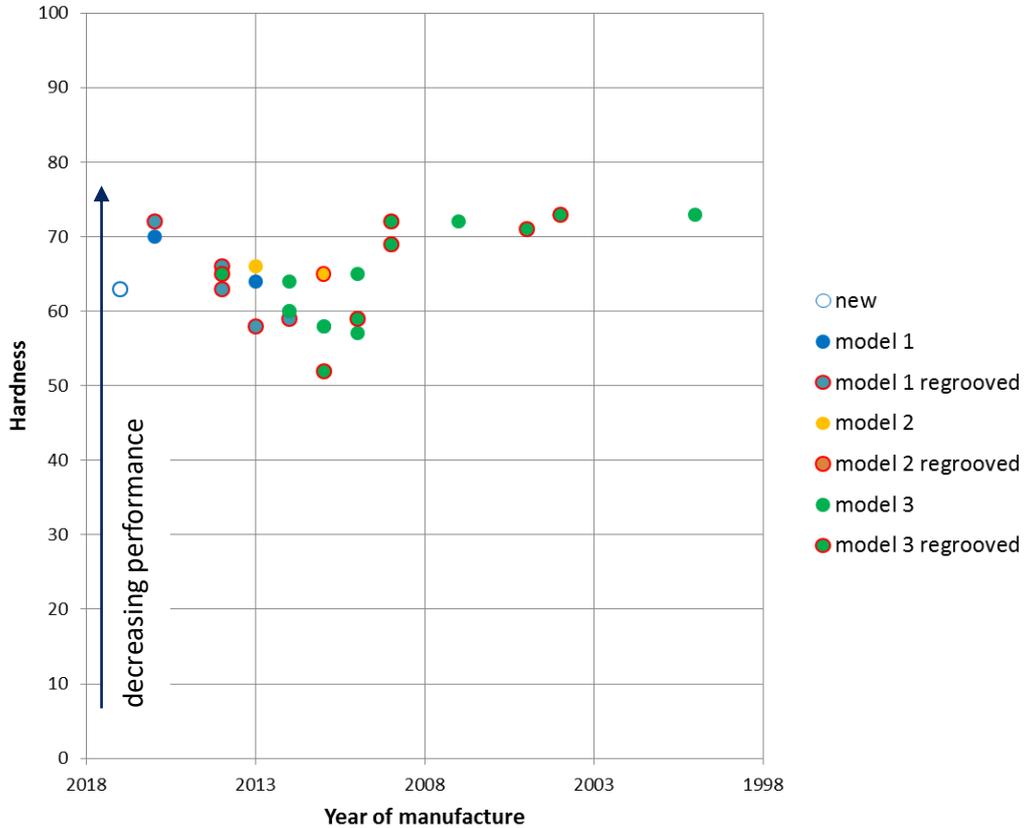
Figure 13: Tread Shore A hardness for service regrooved tyres

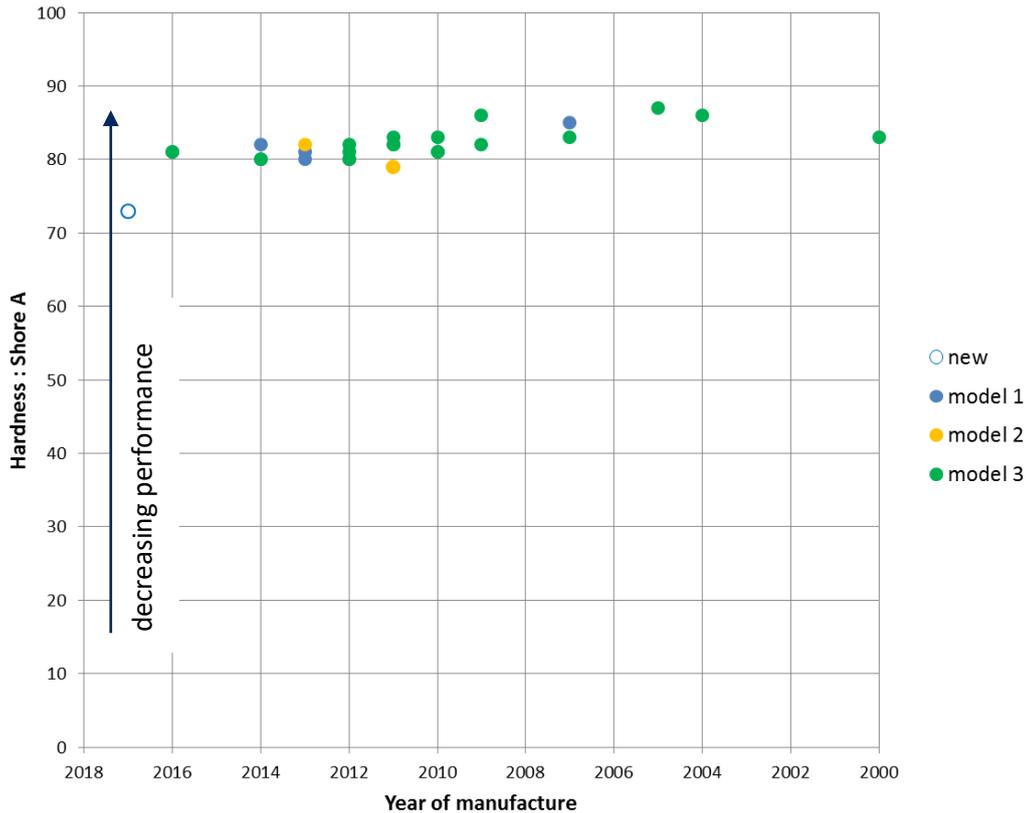
Figure 18: Belt skim Shore A hardness

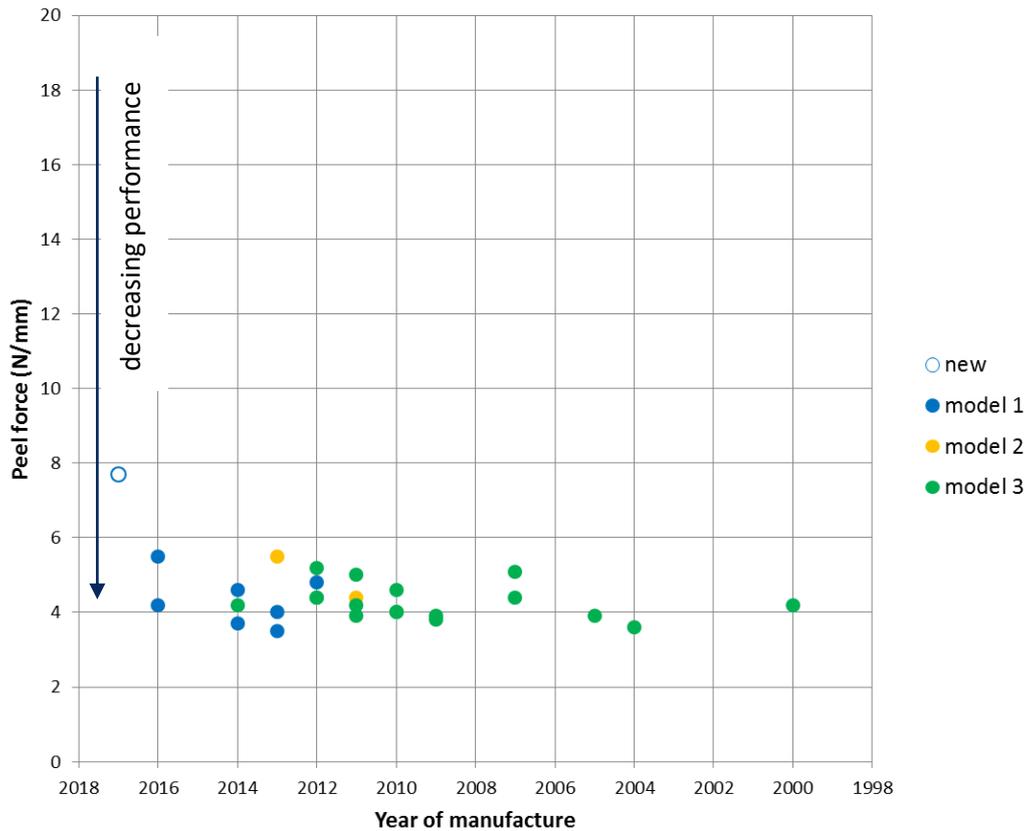
Figure 19: Interfacial peel force, belt 2 to belt 3

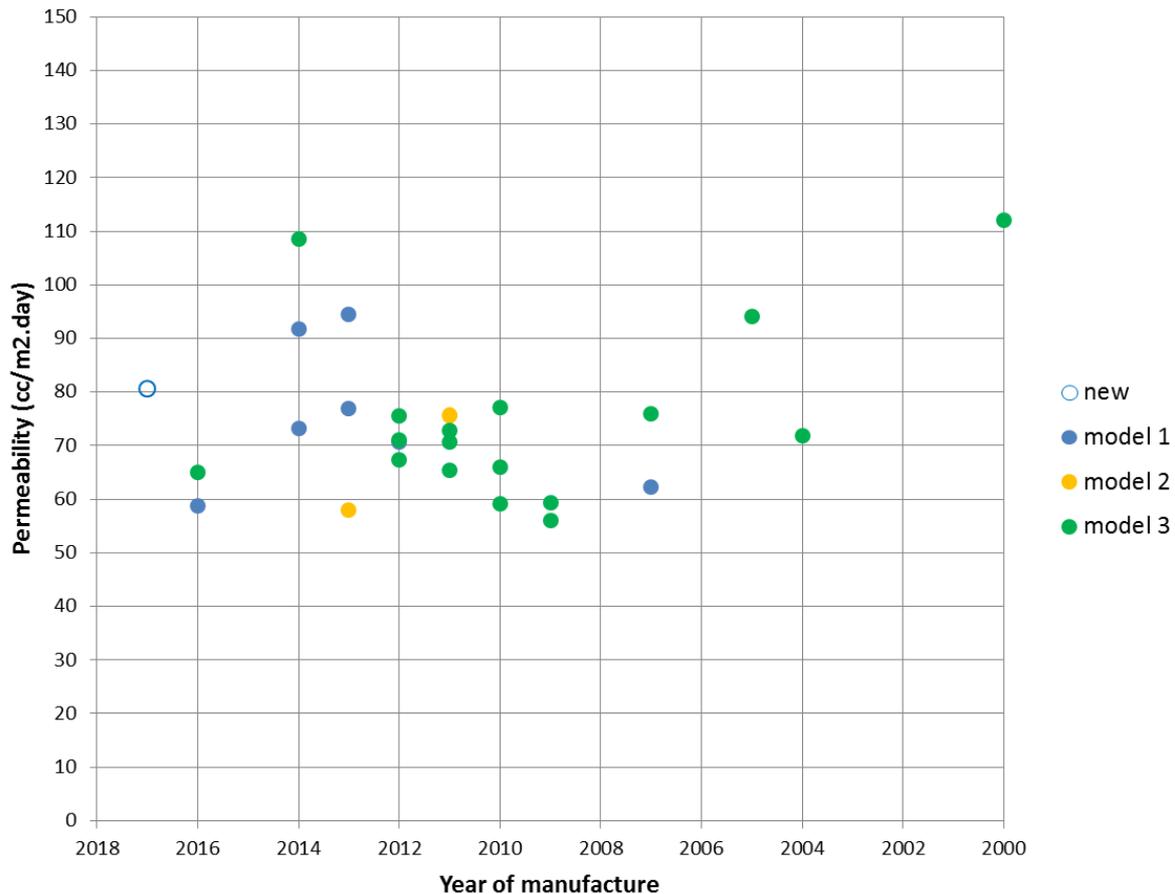
Figure 24: Liner permeability

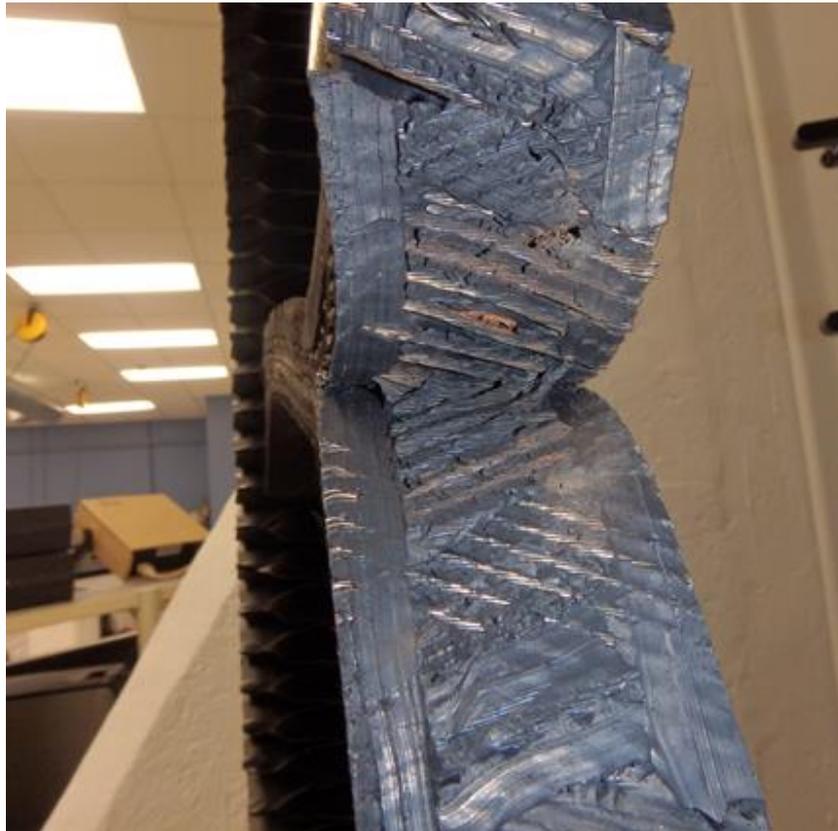
Figure 25: Tyre 44 belt 3 corrosion present

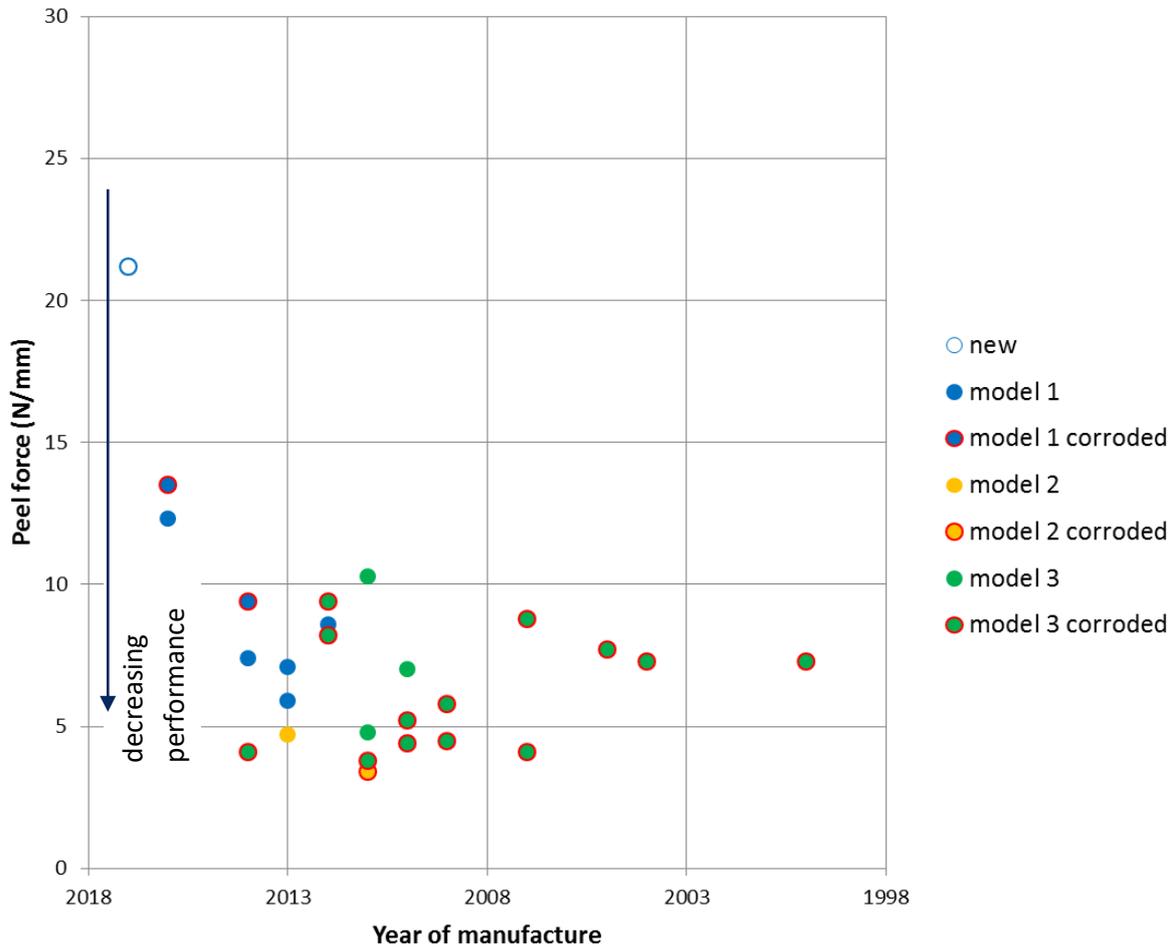
Figure 27: Interfacial peel force belt 3 to 4, with identification of those tyres observed to have corrosion

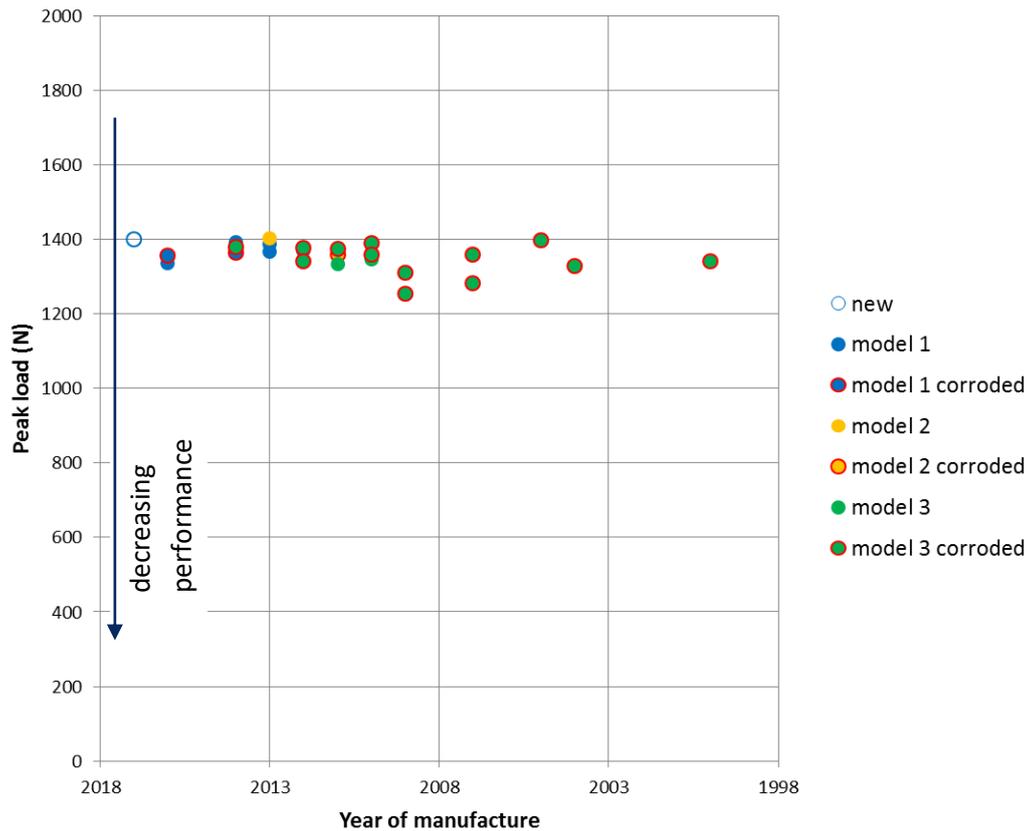
Figure 28: Ply cord peak load, with identification of those tyres observed to have corrosion

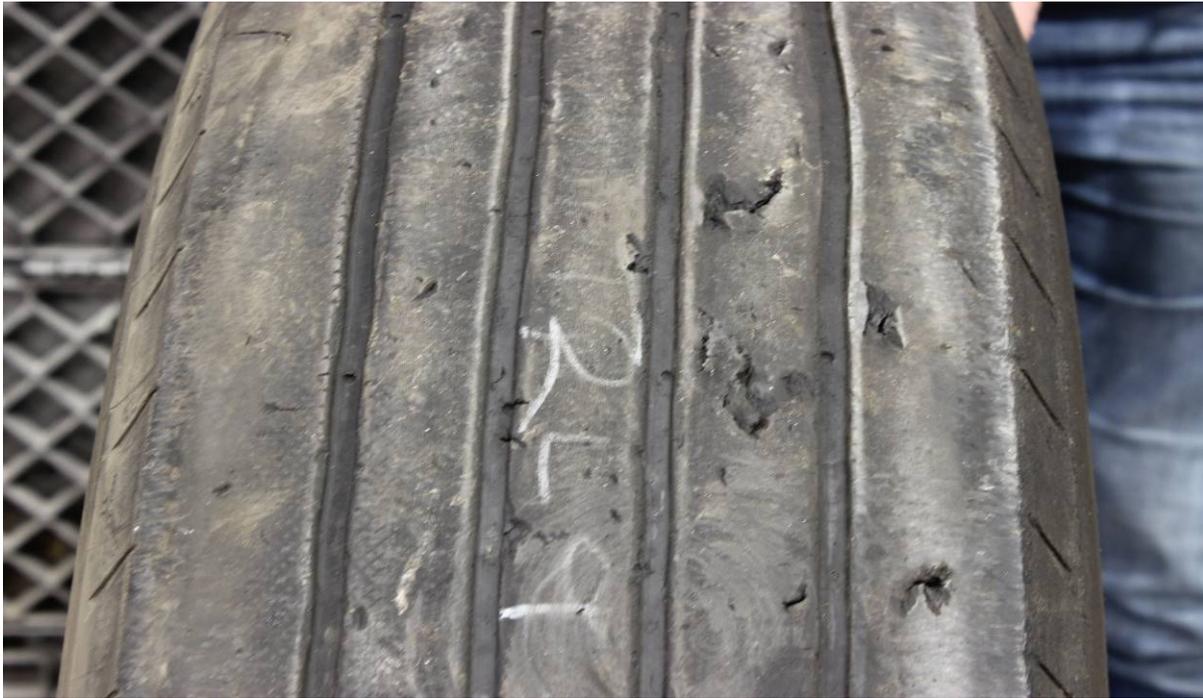
Image 1: Tyre 6 - tread damage. Note that this tyre has been regrooved.

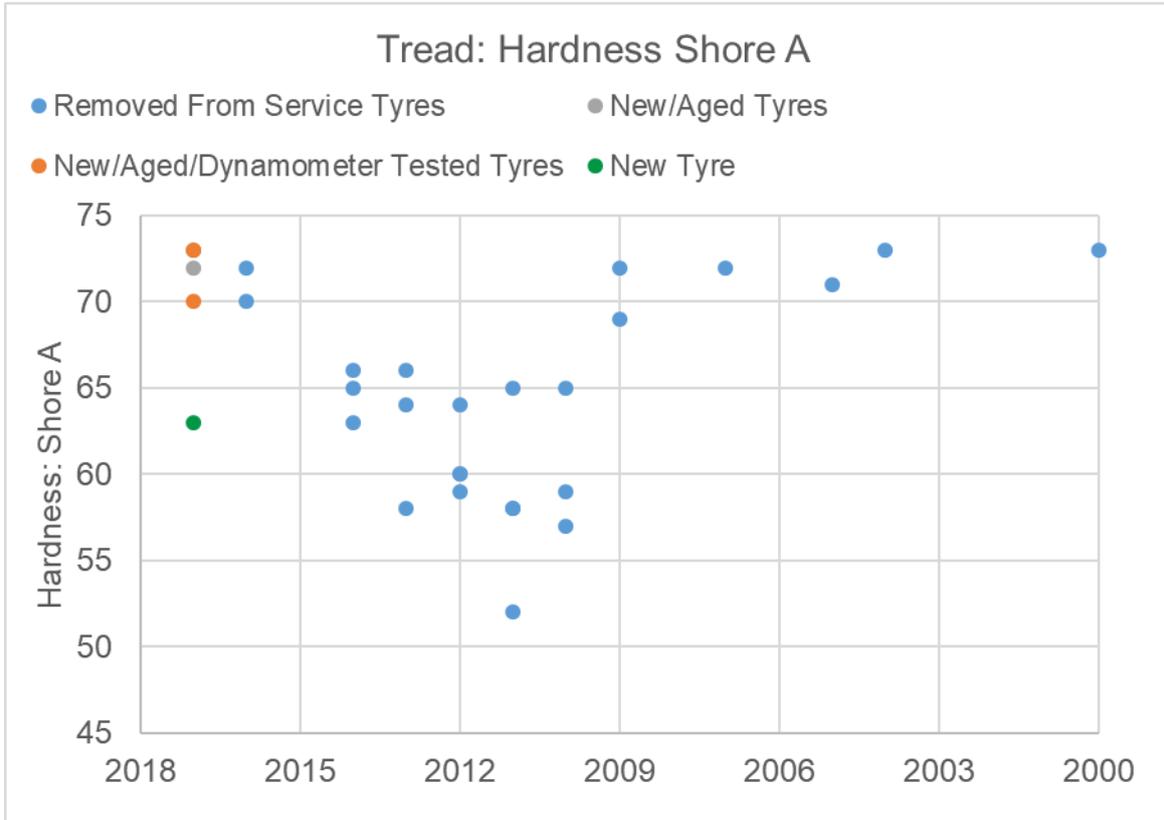
Chart 1: Tread compound hardness.

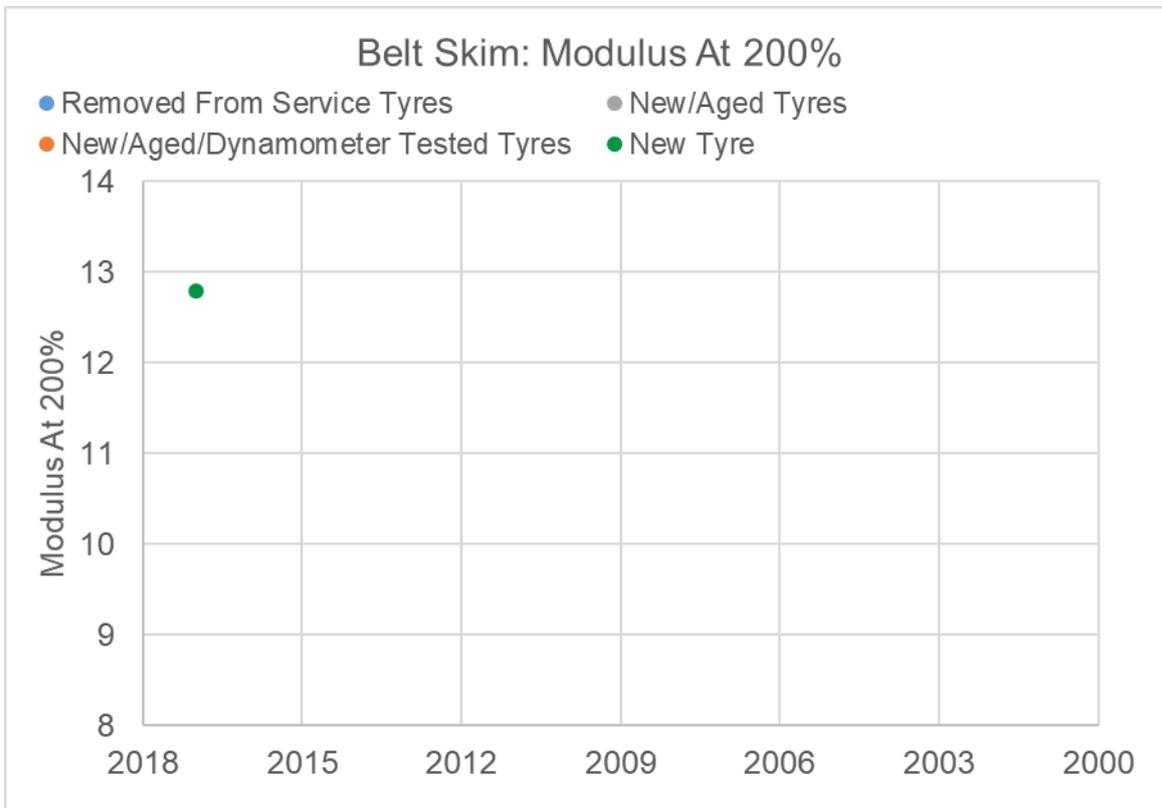
Chart 23: Belt skim modulus at 200% extension. (Note: All samples except the new tyre fractured at elongations less than 200%.)

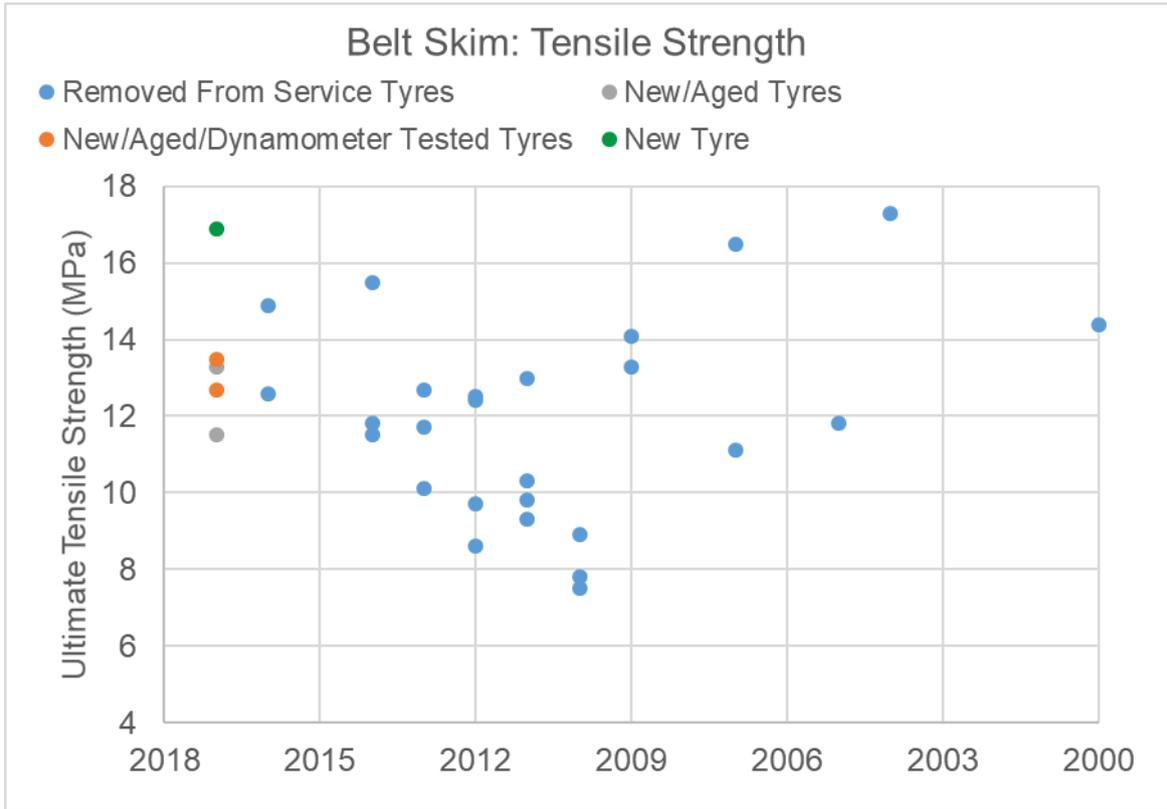
Chart 24: Belt skim ultimate tensile strength.

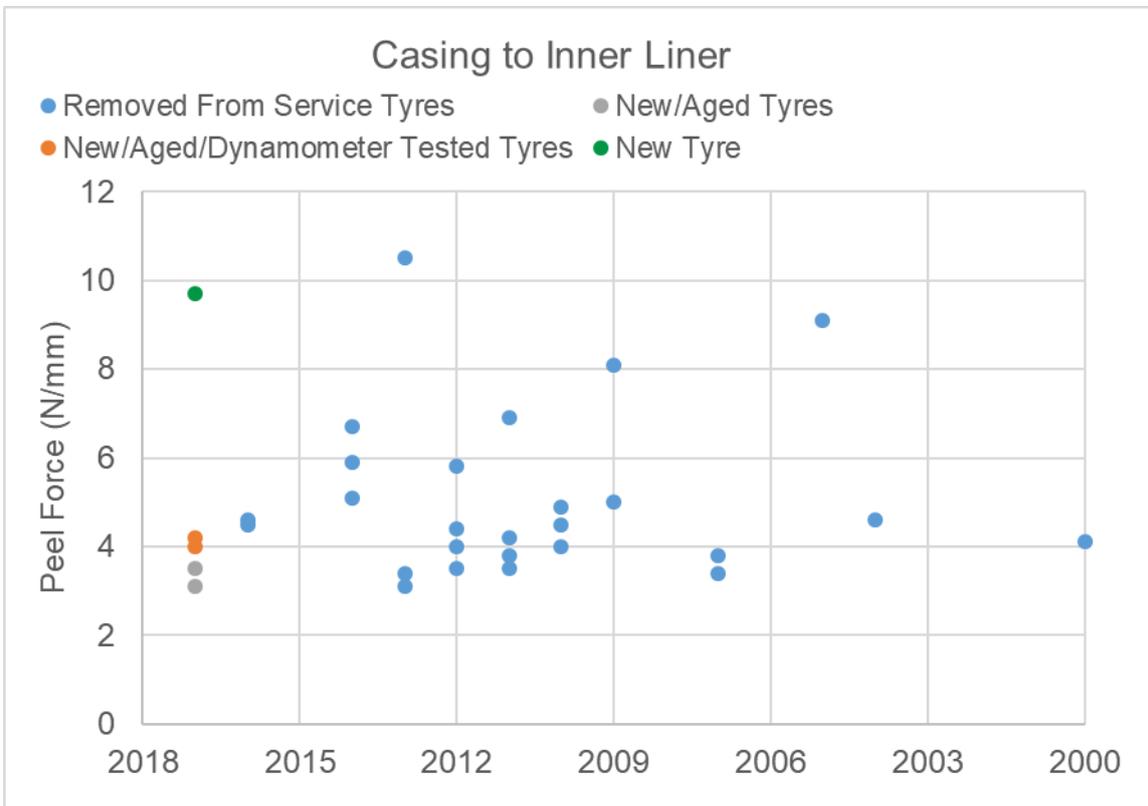
Chart 30: Interfacial peel force– Casing to innerliner.

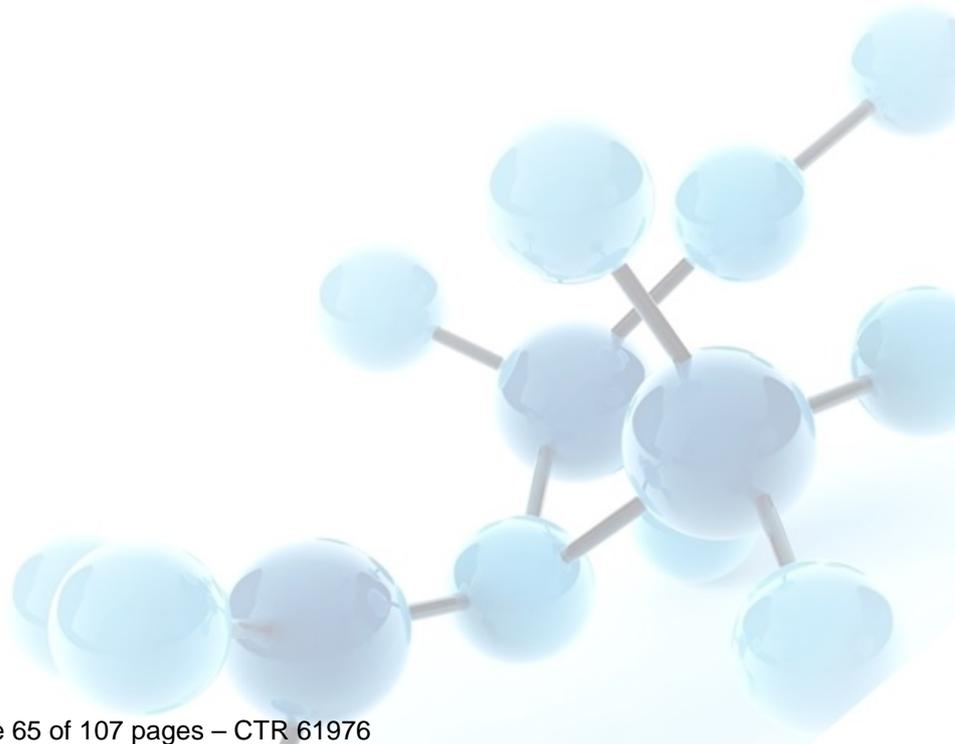
APPENDIX 1 – Shearography Test Results

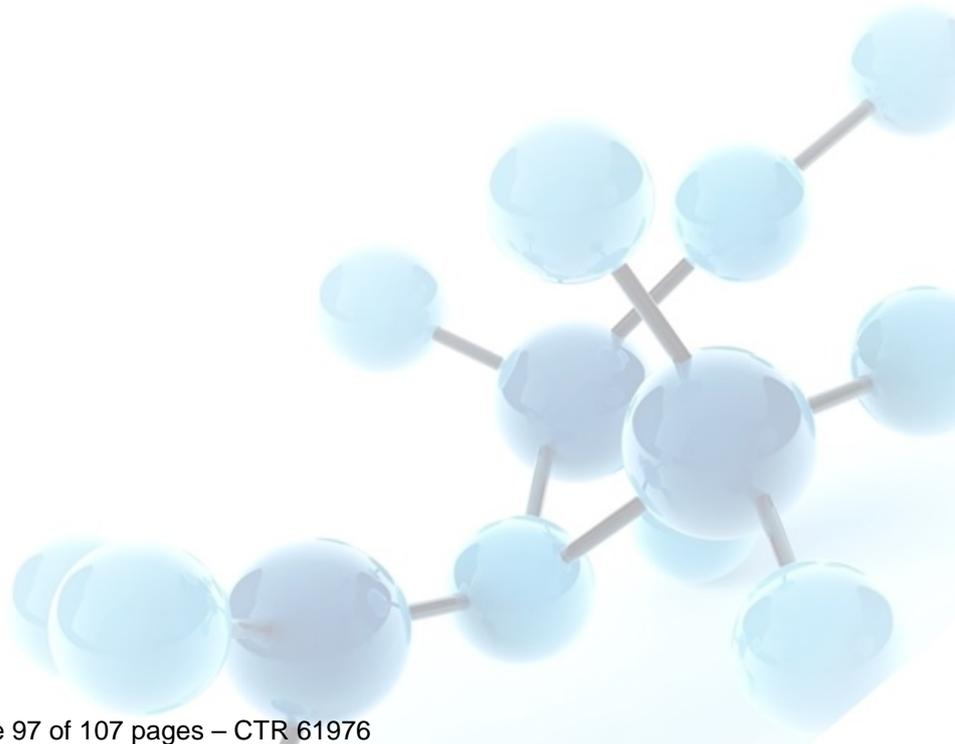
Corrosion Noted on Peel Force Specimens

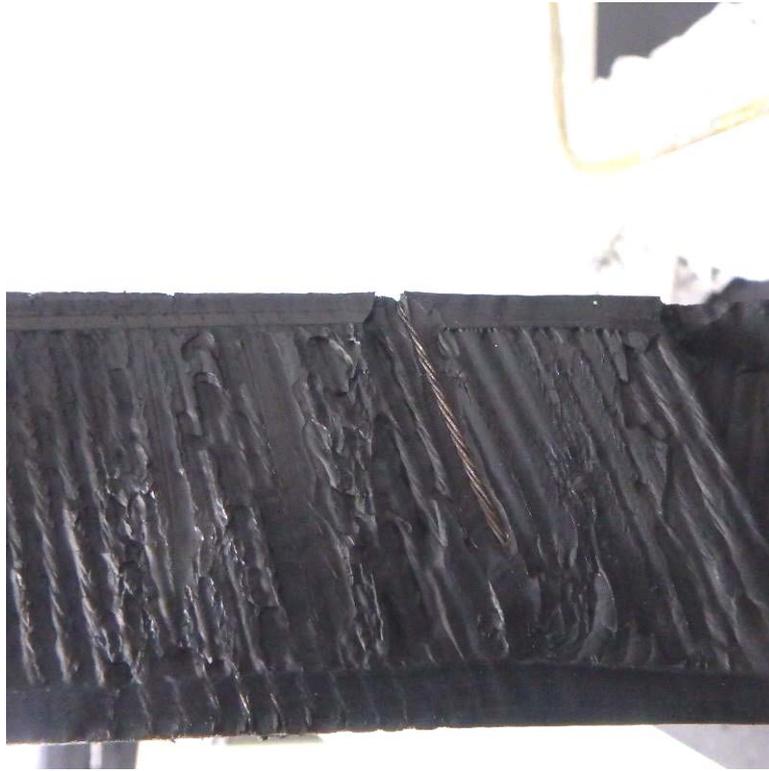
Photograph 1: Tyre 6 Belt 3
